Behaviour of production VPTs for the CMS Endcap Electromagnetic Calorimeter

19 April 2002

This note reports measurements made on the first 700 production Vacuum PhotoTriodes (VPTs) manufactured by RIE (St Petersburg) for the CMS Electromagnetic Endcap Calorimeter. This is an interim report. A more complete report will be produced when all 700 VPTs have been fully tested.

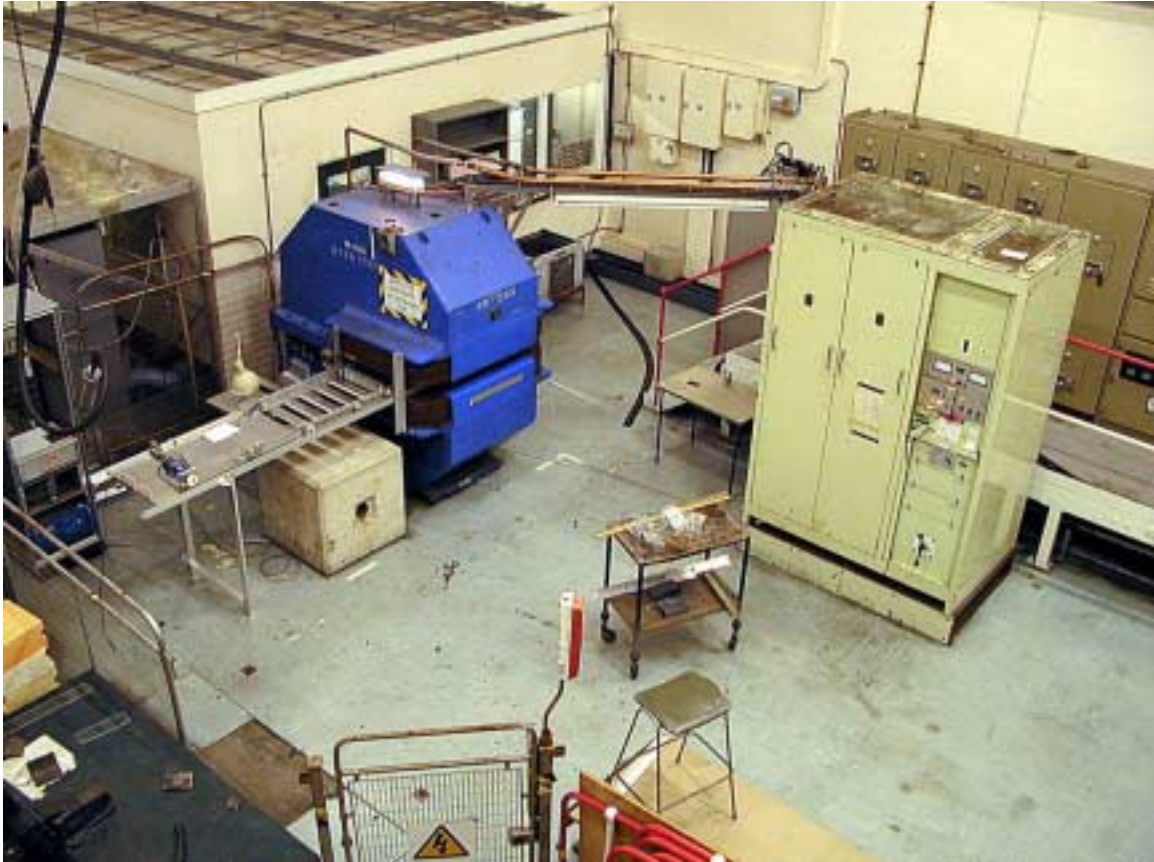
Figure 1 is a photograph of the RAL test rig area. The 1.8T magnet, slightly to the left of centre in the picture, was formerly used as a bending magnet in a beam line.

Figure 1. General view of the RAL test rig

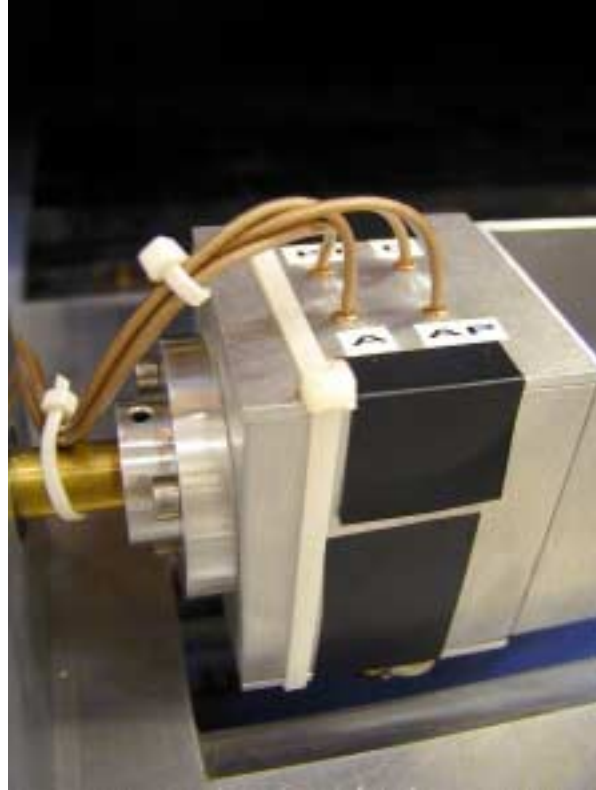
The VPTs are held in aluminium cans; Figure 2 shows an example. Cans are glued together in rows of eight, with each row attached to the rig by a shaft, so that it may be rotated to present the VPTs at any desired angle to the magnetic field. A stepper motor is used to rotate all of the VPTs simultaneously by means of a system of drive belts.

Figure 2. Close-up view of a VPT holder.

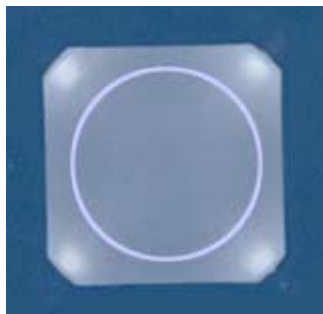
Considerable care has been taken to illuminate the photocathodes as uniformly as possible. Each VPT is illuminated by a diffuser plate equipped with four 430nm LEDs, as illustrated in Figure 3. A metal mask is used to block the direct light from the LEDs, and to reduce electronic pick-up from the LED drive pulse.

Figure 3. Frosted perspex diffuser plate equipped with four 430nm blue LEDs. In operation, the direct light from the LEDs is masked. The circle indicates the unmasked area.

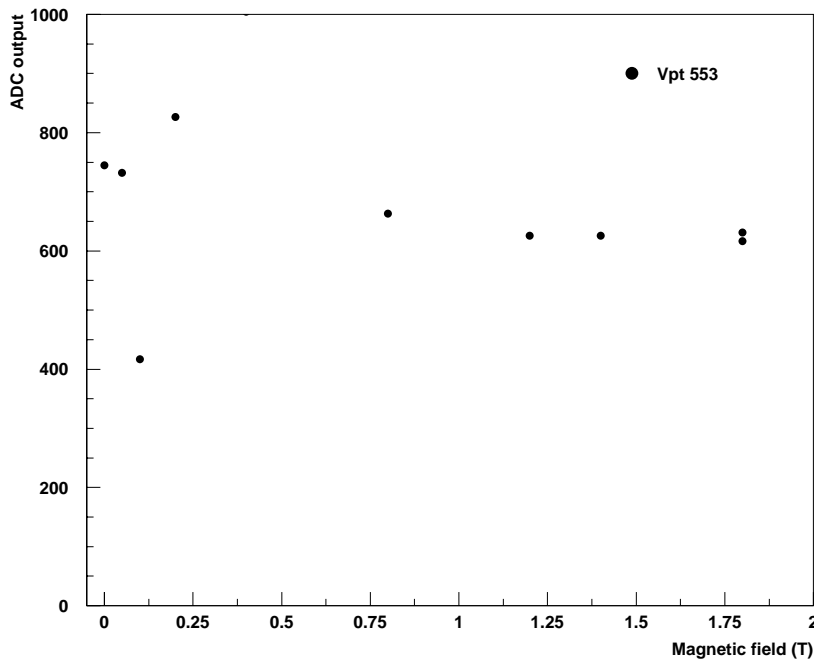
The RAL test rig allows VPTs to be operated at any magnetic field up to 1.8T. A standard part of the testing procedure is to scan the field from 1.8T to 0T with the VPT held at an angle of 15° to the field. After each change of field, a short settling period of about 2 minutes is allowed to ensure that the magnet and the VPTs are stable before starting to pulse the LEDs. 1000 LED pulses are measured at each field point. Figure 5 shows the variation in output with field for a typical sample of VPTs.

Figure 5. Examples of magnetic field scan on a typical VPT.

The VPT in this figure (bar code 553) exhibits a significant instability in the anode pulse size at low field. The pulse width also increases substantially in this field range. Approximately 20% of the VPTs display similar noisy behaviour at fields between 0.1T and 0.8T, though in all cases the tubes are stable at fields above 1T.

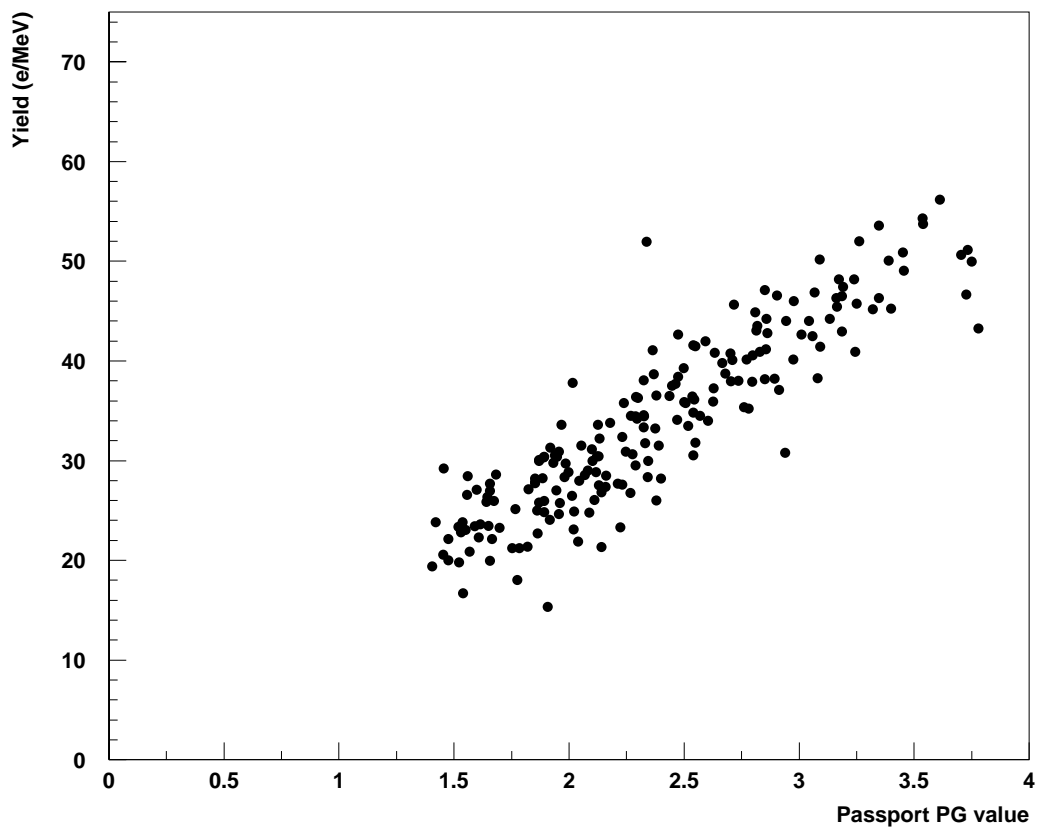
Figure 8 shows the correlation between the mean pulse height in the 1.8T magnetic field and the quality factor PG supplied by the manufacturer. Very similar results are seen with the magnet current set to zero.

Figure 8. VPT response at 8° - 25° and 1.8T v quality factor PG

The first 700 production VPTs supplied by RIE have been subjected to a variety of measurements at RAL and Brunel. All have been visually inspected, and approximately 300 have so far been tested in the RAL 1.8T test rig. The data supplied in the VPT passport is found to correlate well with these measurements. The overall quality factor *PG* is well-correlated with the measurements in the test rig.
